# Applying microscopic analytic techniques for failure analysis in electronic assemblies

The present paper gives an overview of surface failures, internal nonconformities and solders joint failures detected by microscopic analysis of electronic assemblies. Optical microscopy (stereomicroscopy) and Fourier-Transform-Infrared (FTIR) microscopy is used for documentation and failure localization on electronic samples surface. For internal observable conditions a metallographic cross-section analysis of the sample is required. The aim of this work is to present some internal and external observable nonconformities which frequently appear in electronic assemblies. In order to detect these nonconformities, optical microscopy, cross section analysis, FTIR-microscopy and scanning electron microscopy with energy dispersive spectrometry (SEM-EDS) were used as analytical techniques.

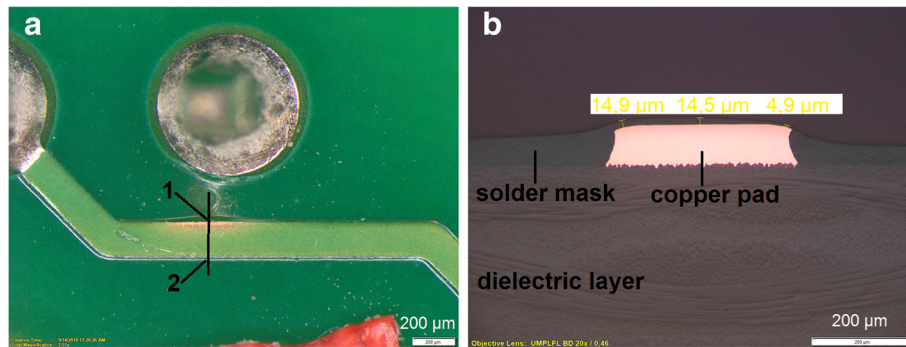
**Fig. 1** Optical microscopy evaluation of the uncovered conductor (a) and detailed view in the cross-section of the solder mask thickness (b)

The solder mask is a heat-resisting coating material applied to selected areas to prevent the deposition of solder upon those areas during subsequent soldering. The cured solder mask shall be uniform in appearance and free of any surface anomaly that would interfere with the assembly or operation of the printed board. In the Fig. 1a, the solder mask is missing from the copper conductor. The lack of metallic luster during the evaluation of the specimen indicates a too small thickness of the solder mask. The evaluation of the cross-section (Fig. 1b) shows a solder mask thickness of 15 µm in the position with acceptable solder mask thickness (position 2 in Fig. 1a) and a thickness of 4 µm in the position where the solder mask is missing (position 1 in Fig. 1a).

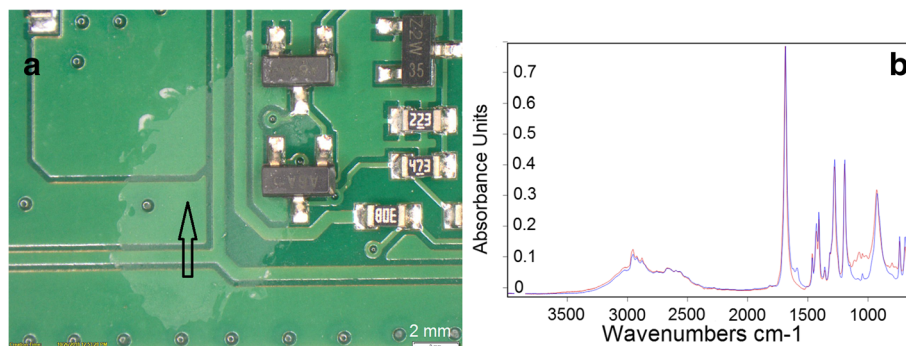
In the most cases, the appearance of the white residues indicates the presence of flux traces. Figure 2a shows a

contaminated area direct on the PCB surface. In order to confirm that the observed contamination correspond to flux residues, a FTIR-microscopy analysis using the ATR-technique (attenuated total reflection) was performed directly at the contaminated area on the PCBA surface. The founded spectral data (Fig. 2b) clearly show the presence of adipic acid, the active part of the flux system. The recorded spectra (red line) fully corresponds to the library spectrum (blue line, adipic acid, Zollner own library) seen by the measured absorption bands: ca.  $3000\text{ cm}^{-1}$  (–O–H stretch and –C–H stretch),  $1700\text{ cm}^{-1}$  (–C=O stretch),  $1430\text{ cm}^{-1}$  (–O–H bend),  $1280\text{ cm}^{-1}$  (–C–O–stretch),  $930\text{ cm}^{-1}$  (–O–H bend). The peak near  $1100\text{ cm}^{-1}$  in the spectra marked with red line is attributed to solvent residues of the flux remained in the white residue. Any flux residues on electrical contact surfaces is not accepted by the standard (Huang et al. 2009; IPC-A-610 Revision G 2017).

**Fig. 2** Microscopic investigation of white residues presents on the PCBA surface (a) and FTIR spectra analysis of the identified contamination (b). The recorded spectrum is marked with red line, the library spectrum with blue line

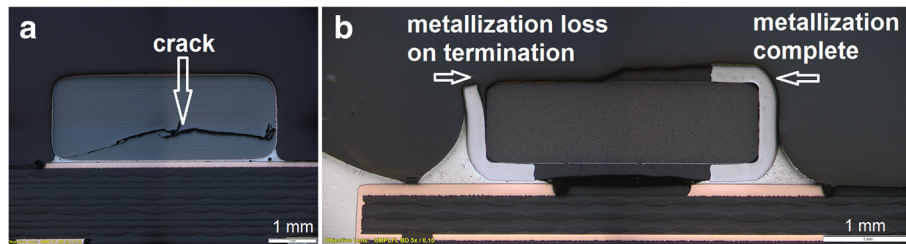
The used components should be in a perfect condition and fulfill the technical specifications. Minor deviations on surface damages can be accepted if the functionality of the component is given. Major component damages such as crack in the component body (Fig. 3a) or

**Fig. 3** Cracked component (a) and metallization loss on upper termination side at a glass diode (b) (Figure captured using Olympus BX61 metallographic microscope at a magnification factor of 50x)

metallization loss on termination side (Fig. 3b) are not accepted (IPC-A-610 Revision G, 2017).

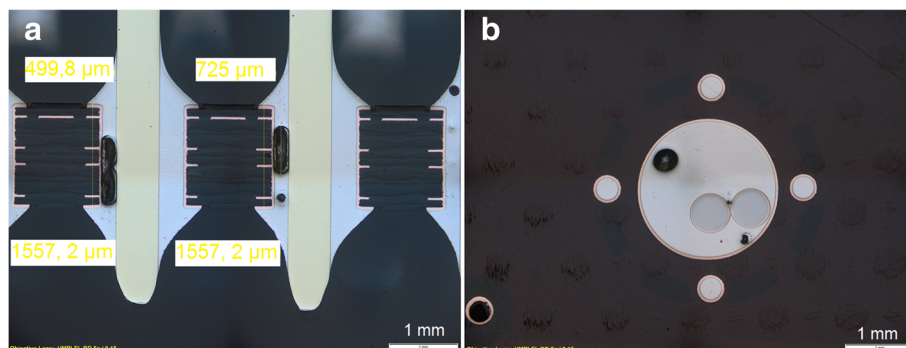
**Voids and cavities in through hole technology (THT) solder joint** In this example (Fig. 4a and b) voids and cavities are visible in the solder joints for the through holes components. They are due to outgassing from the organic base material contained in flux. Possible causes for the outgassing occurrence are the humidity in the base material, organic contamination on the leads, pins and holes. The large cavities increase the susceptibility for voids of solder joints and therefore, impair their mechanical robustness. These voids and cavities are not visible from outside; an inspection is not possible excepting an X-Ray analysis. Only the cross-cut analysis can detect the size of the cavities and pores. The vertical fill with solder paste is < 75% (measured value: 32,1%) as specified in the standard, so that this solder joints are not acceptable (IPC-A-610 Revision G 2017). These solder joints should undergo rework (possible reflow).

**Fig. 4** Pores and cavities in through-hole solder joint. The measured vertical fill with solder paste for the left solder joint is 499.8  $\mu\text{m}$ , the height of the THT hole is 1557.2  $\mu\text{m}$ . So the vertical fill with solder paste is calculated by  $(499.8/1557.2) \times 100\% = 32.1\%$ . The void in the left solder joint is about 67,9% of the vertical height of the solder joint, in the right solder joint the void is about 53,3%. The vertical fill with solder paste is < 75% as specified in the standard, so that this solder joints are not accepted (a). Also in the horizontal cross-section voids can be found in the solder joint. In this case the solder joint is well formed, the void does not influence the mechanical stability of the solder connection (b) (Figure captured using Olympus BX61 metallographic microscope at a magnification factor of 50x)

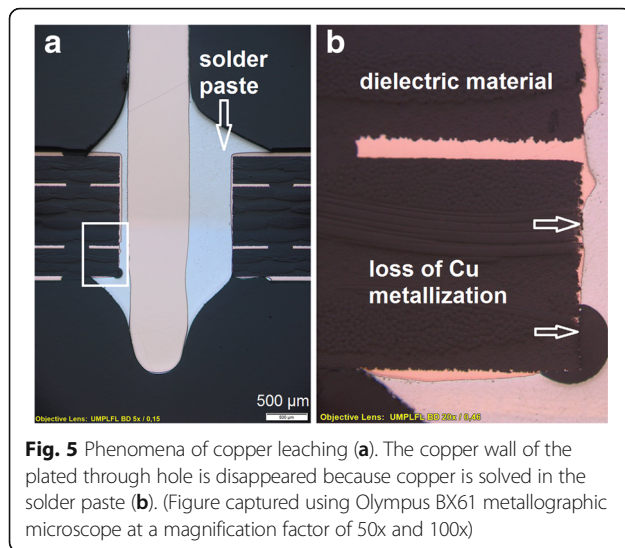
**Copper leaching** In Fig. 5 the phenomena of copper dissolution can be observed. The copper wall of the plated through hole is disappeared because the copper is solved in the solder paste (Fig. 5 phenomena was marked with white arrows). Not only disappearance but also thinning of copper layers may induce to disconnection problems, which are not desirable from the view-point of the joint reliability. Possible cause can be a too high soldering temperature or a too long soldering time. The Sn-Ag-Cu alloy is reactive to metals (for example copper or iron), the dissolution or/and disappearance of copper layers is a problem on wave soldering where PCBs are dipped in molten solder paste (Izuta et al. 2007; Snugovsky et al. 2009).

**Fig. 5** Phenomena of copper leaching (a). The copper wall of the plated through hole is disappeared because copper is solved in the solder paste (b). (Figure captured using Olympus BX61 metallographic microscope at a magnification factor of 50x and 100x)

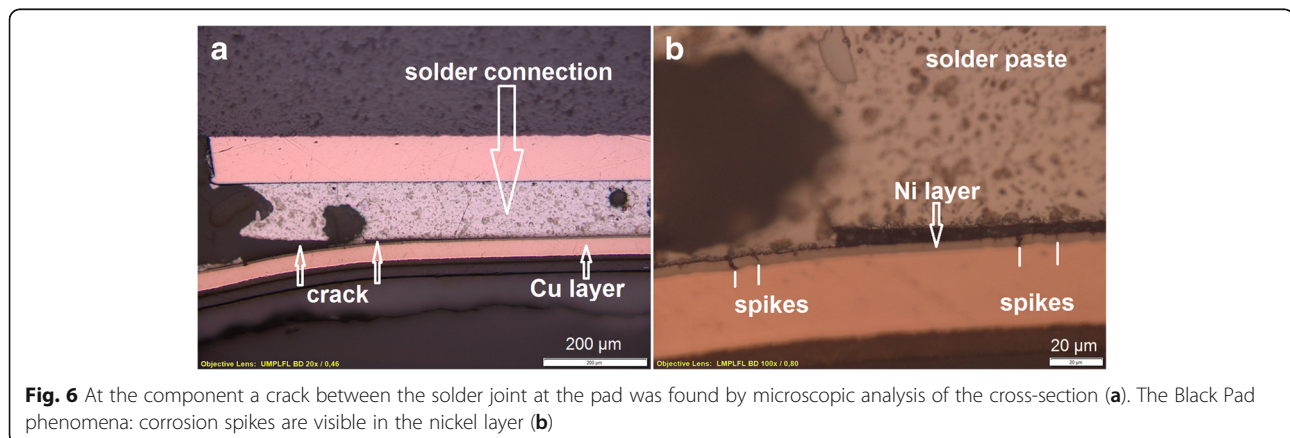
At the presented component soldered on a FBA an electric malfunction was found. To determine the root-cause of the defect, a microscopic verification of the prepared cross-section was done. The microscopic examination approve the presence of a crack in the solder joint (Fig. 6a). The crack is formed between the intermetallic layer and the Nickel-layer of the pad on a PCB with ENIG

surface (electroless nickel/immersion gold). Figure 6b shows a corroded Black Pad structure: corrosion spikes are visible in the nickel layer. Black Pad failures are a nickel corrosion process. The main features of the phenomenon are partial wetting by solder of certain ENIG areas, the presence of Ni surface morphology defects (mud cracks, spikes) and black spots. The Black Pad phenomena in the corroded nickel surface results in the loss of solderability and that has caused poorly formed solder joints at the interface between the solder and the nickel interface. When such weakened solder joints are subjected to mechanical stress, they can be easily fractured (Hui Lee 2011; Ramanauskas et al. 2013; Snugovsky et al. 2001; Snugovsky, 2002; Susan et al. 2004).

**Fig. 6** At the component a crack between the solder joint at the pad was found by microscopic analysis of the cross-section (a). The Black Pad phenomena: corrosion spikes are visible in the nickel layer (b)

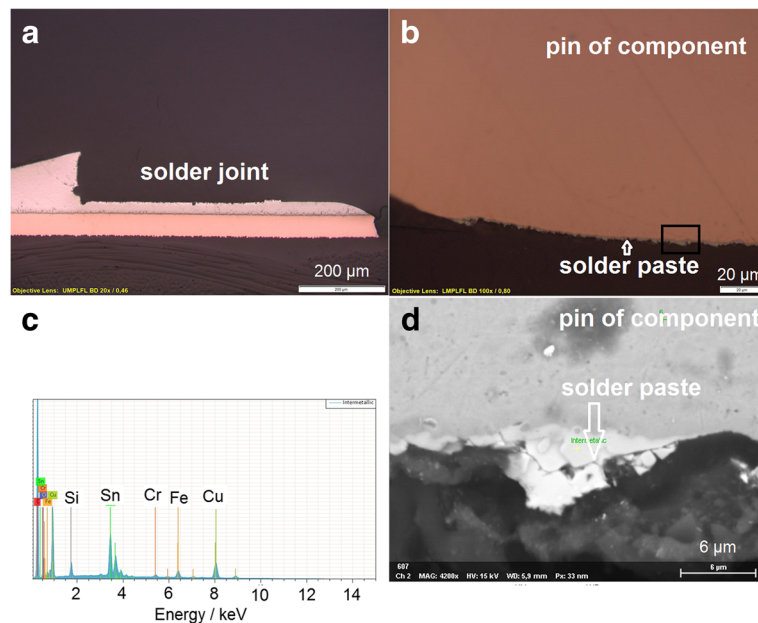
**Damaged solder joint and fallen component** In the present case a missing component from the assembled printed circuit board was observed (Fig. 7a). The component was separated from the solder joint where the original form of them can be observed. The microscopic verification

of the components pin at the maximum magnification factor of the metallographic microscope (1000x) confirms the presence of solder paste (Fig. 7b). The use of a scanning electron microscope which allows a higher magnification (picture was taken at a magnification factor of 4200x) indicates the presence of solder paste on the pin (Fig. 7d). The EDS-analysis performed at this point shows the presence of tin and copper, which are the mainly elements in the composition of the solder paste and of the intermetallic layer (Fig. 7c). The evidence of tin on the components pin shows that the pin was soldered to the PCB. Probably due to a mechanical stress the strength of the solder joint became weaker and the component was separated from the PCB.

**Fig. 7** Microscopic overview of solder joint with missing component (a). Missing component (b). EDS-analysis of solder paste (c). SEM analysis of component pin (d)

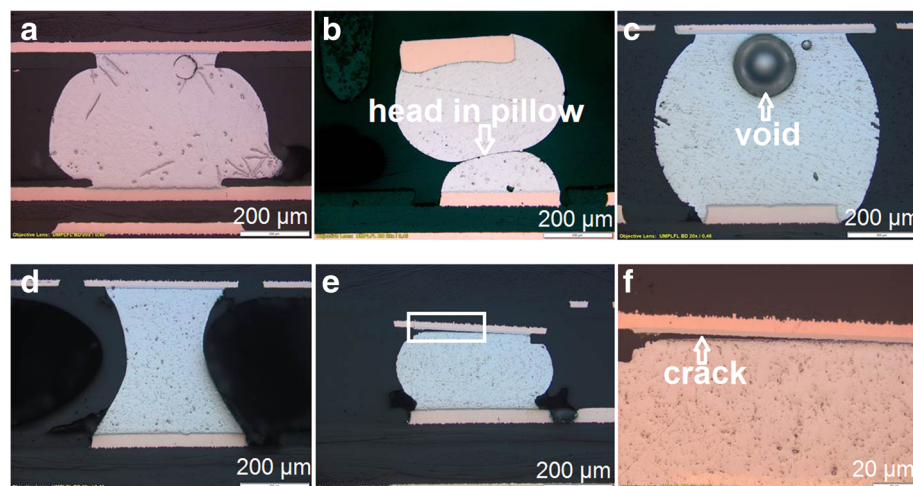
**BGA (ball grid array) defect** A ball grid array (BGA) is a type of surface-mounted devices used for integrated circuits. BGAs use solder bump interconnections instead of pins. Once the package is soldered into place, it is difficult to find soldering faults. X-ray analysis, industrial computed tomography scanning and endoscopy are non-destructive analysis methods which can be used to identify the soldering faults. To find the real root cause of the soldering fault the cross-section analysis offers good possibilities to reach this goal. Figure 8 shows possible soldering failures on BGA components:

- ➡ BGA ball with macrovoid (Fig. 8c). Macrovoids are caused by volatile compounds that evolve during the soldering processes. These macrovoids generally do not affect the solder joint reliability unless they are present at interfacial regions in the solder joints where cracks typically propagate.
- ➡ Head-in-pillow (Fig. 8b) is a solder joint defect where the solder paste wets the pad, but does not fully wet the ball. For example, in the case of a ball grid array, the predeposited solder balls on the component and the solder paste applied to the circuit board may both melt, but the melted solder does

not join. The cross-section through the failed joint shows a distinct boundary between the solder ball on the component and the solder paste on the circuit board. This solder joint fulfills the conditions for a connection to have electrical integrity, but is lacking sufficient mechanical strength. Due to the lack of solder joint strength, this component may fail with very little mechanical or thermal stress. The defect was probably caused by surface oxidation or poor wetting of the solder.

➡ Deformed solder ball (Fig. 8a, d). The dynamic warpage of the PCB and/or BGA can lead to varying shapes of solder joints. The left solder joint in the upper row (Fig. 8a) shows a convex solder joint. The warpage can lead also to solder joint being stretched into a columnar shape (figure left in the lower row Fig. 8d). Both solder joints are acceptable from a quality standpoint (IPC-7095D 2018).

➡ Crack in solder joint (Fig. 8e, f). A cracked or fractured solder ball is not accepted. This failure can be

**Fig. 8** Possible soldering failures on BGA components: deformed solder ball (a and d), head in pillow (b), voids (c) and crack in solder joint (e and f)

caused by mechanical stress, for example the BGA was not aligned parallel to the PCB surface (Champaign and Wiggins 2007; Hofmeister et al. 2008).
